CLARENCE J. BROWN RESERVOIR
GREATER MIAMI RIVER BASIN
OHIO

EMBANKMENT CRITERIA AND
PERFORMANCE REPORT

PREPARED BY
U.S. ARMY ENGINEER DISTRICT, LOUISVILLE
CORPS OF ENGINEERS

SEPTEMBER 1982

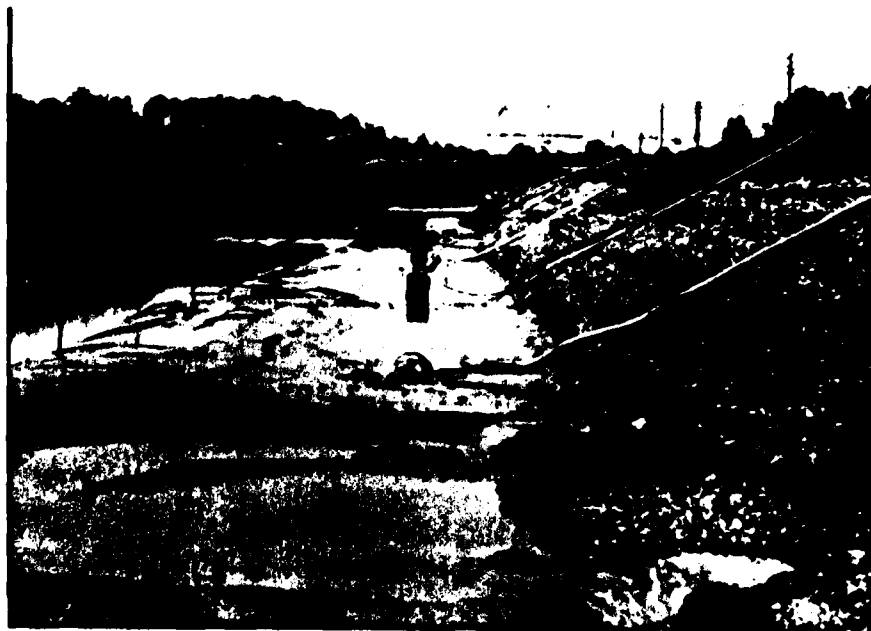
(2) Water accumulation in core trench area after encountering artesian well in core trench at station 24+10.

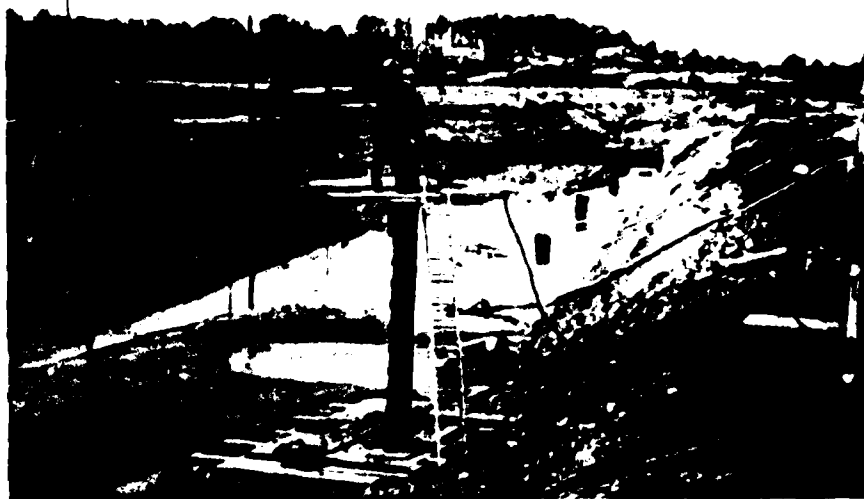
(5) View of artesian well and extension of 12" casing at dam E station 24+10. (September 1971).

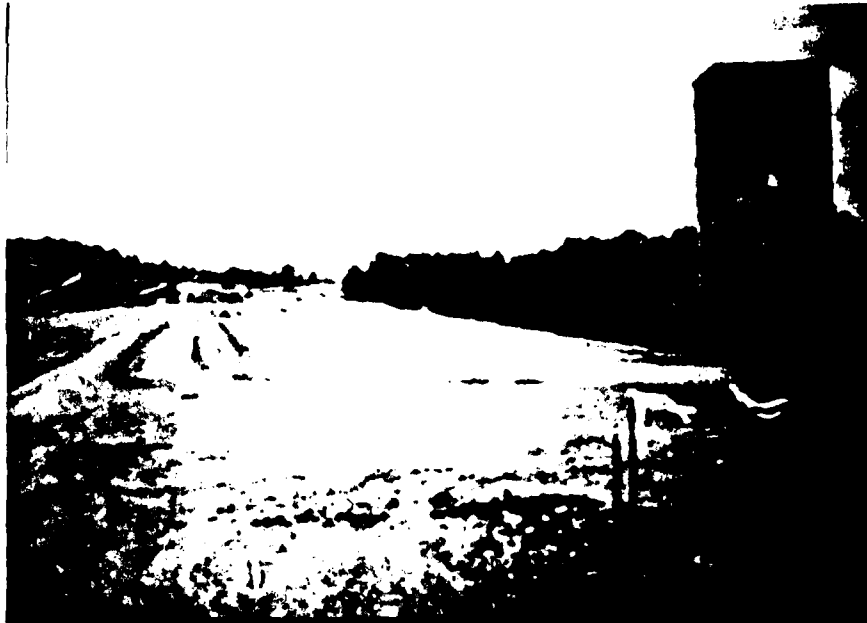
(13) Embankment looking toward right abutment with fill at elevation 993. (August 1972).
